# The Deterioration of Stainless Steel Regeneratively Cooled Thrust Chambers

Prepared by J. K. STANLEY  
Materials Sciences Laboratory

Air Force Report No.  
SAMSO-TR-69-353

Aerospace Report No.  
TR-0066(5250-10)-9  
(Formerly TR-0200(4250-10)-1)

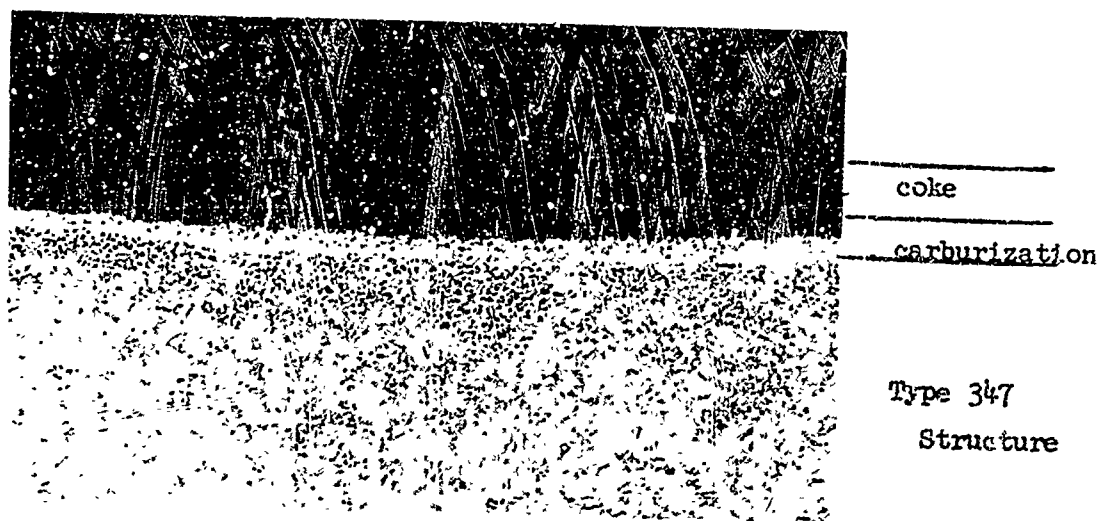
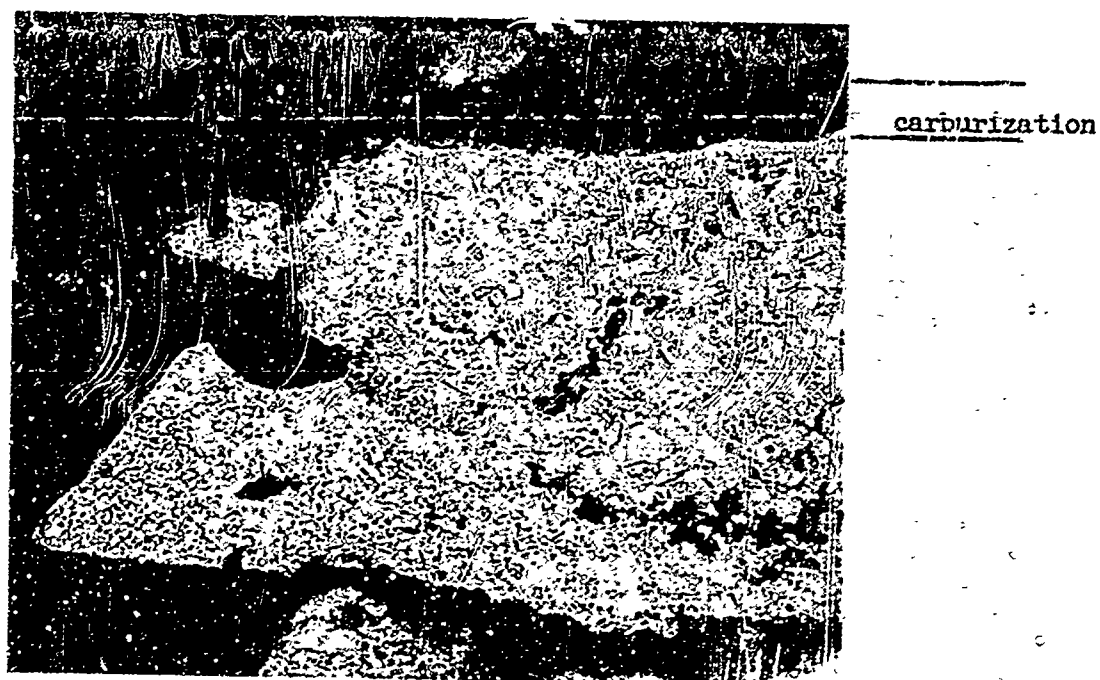
Figure 4. Edge of Fracture on Burnout Failure  
(Etched in Aqua Regia)

Photomicrograph Fig. 4(a) shows the coke formation and some carburization beneath the coking inside the tube in the vicinity of the failure (burnout); Fig. 4(b) shows the edge of the fracture and the voids show that the metal was separating at the increased temperature.

(a) Carbon deposits formed on inside of tube as a result of Aerozine-50 decomposition. 200 X

(b) Voids due to high temperature ruptures prior to complete tube separation. 200X

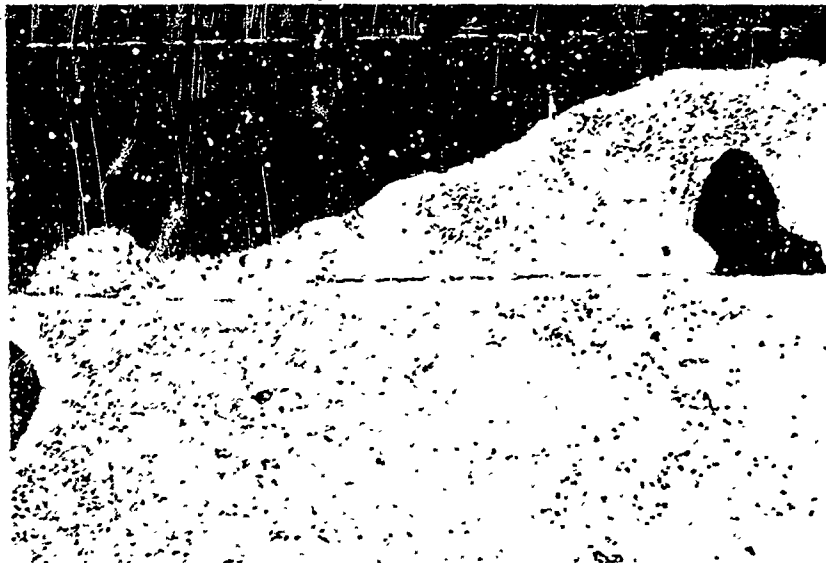
Figure 5. Other Features at Edge of Failure on  
Burnout Sample  
(Etched in Aqua Regia)

Figure 5(a) shows the microstructure in the vicinity of tube cracking. Wall thinning is probably explained by melting of the metal [1370°C (2500°F) to 1425°C (2600°F)]; Fig. 5(b) shows the resolidified steel (area with dendrites) adhering to the tube.

(a) Cracking and wall thinning in area of burnout  
100X

(b) Areas of dendritic structures are resolidified  
metal adhering to wall 200X

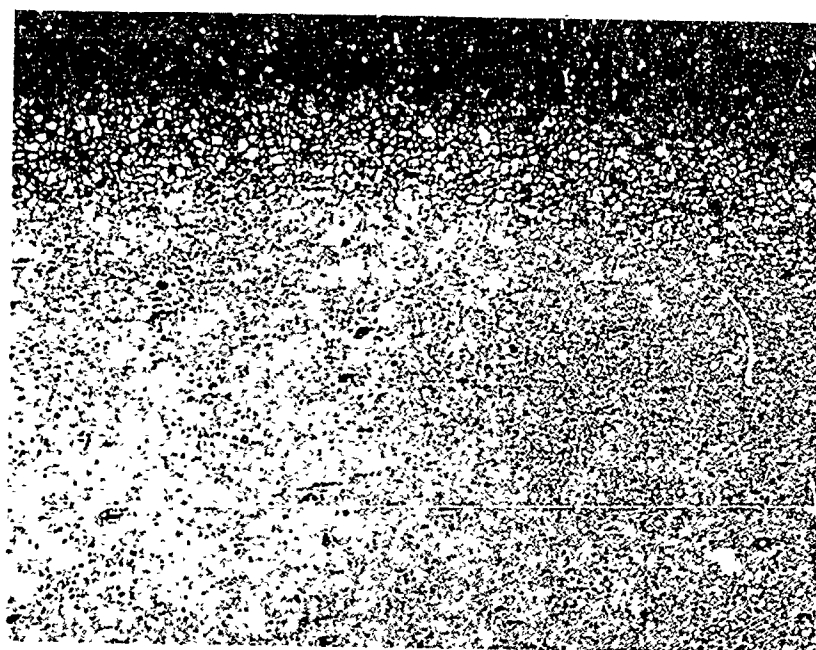
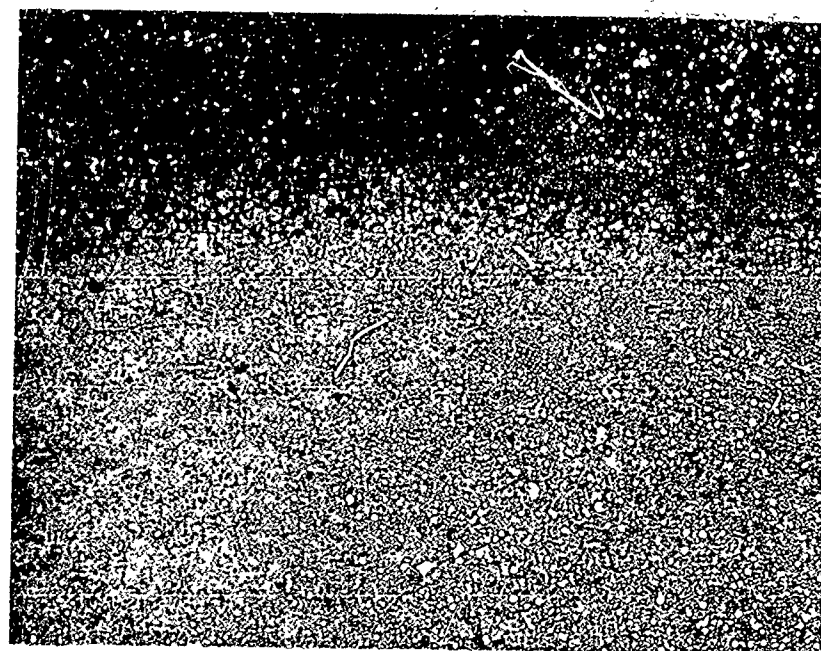
Figure 7. Micrographs of Rapidly Carburized Type 347 Stainless Steel

Carburization of Type 347 stainless steel only occurs above about  $780^{\circ}\text{C}$  ( $1530^{\circ}\text{F}$ ) (Ref. 7). Carburization at high temperatures can be quite rapid. As shown in Fig. 7(a) significant carburization of Type 347 can occur in 1 min at  $1095^{\circ}\text{C}$  ( $2000^{\circ}\text{F}$ ); Fig. 7(b) shows some of the carbide that has melted and resolidified (thin white layer). This is not an unreasonable temperature to be experienced by these tubes in this application. Note coarse grain size in Fig. 8, which attests to this temperature range. Also note the carburized (mottled) layer on the tube.

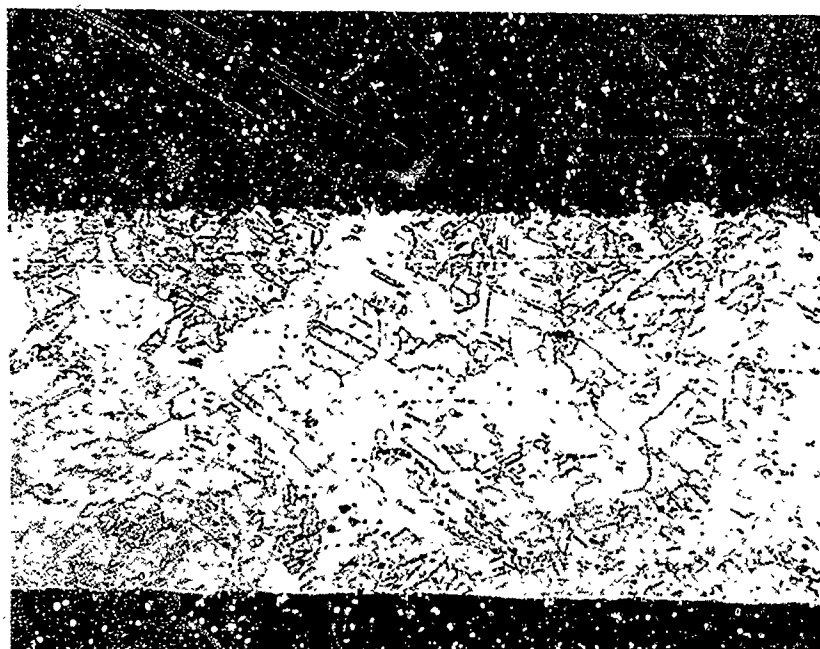
Figure 8. Micrograph of Heat Marked Tube  
(Black lines above and below micrograph are  
separations between steel and mounting  
medium. )

Roughening of tube material often occurred. Roughening due to the resolidification of remelted braze material was referred to earlier (Fig. 8). Roughening, representing metal loss, was often found in association with pinholes and cracks.

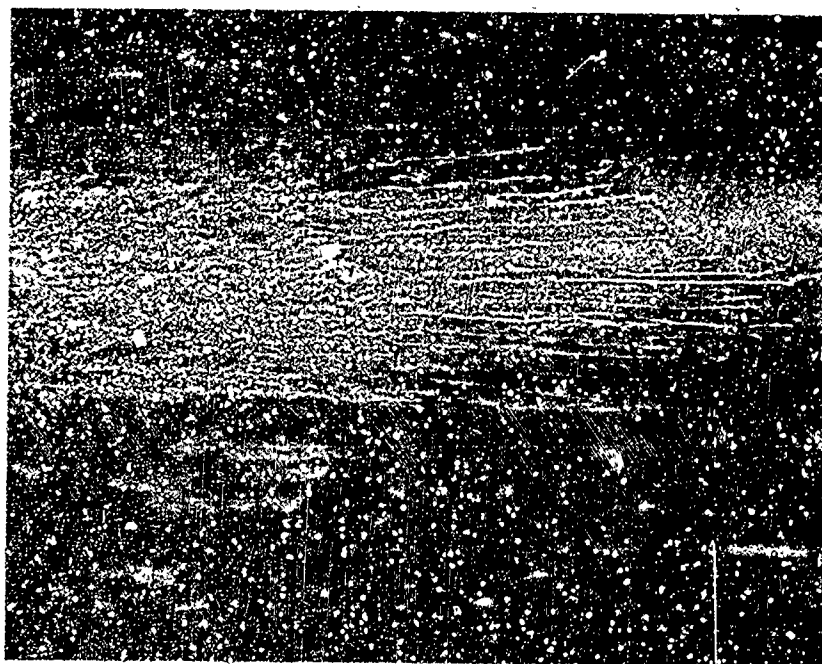
Figure 9. Two Types of Deposits Found on Type 347 Thrust Chamber Tubes  
(Both are a carbide,  $\text{Cr}_7\text{C}_3$ )

Occasionally, solidified beads or crystallized metal, apparently melted from the tubes, appeared on the combustion side of the chamber. Figure 9(a) shows a beaded spray and Fig. 9(b) shows the crystallized metal. This material had been assumed to be molten metal, but x-ray analysis identified it as a  $\text{Cr}_7\text{C}_3$  carbide.

Various melting temperatures were observed for this carbide, some as low as  $1095^{\circ}\text{C}$  ( $2000^{\circ}\text{F}$ ) and some as high as  $1260^{\circ}\text{C}$  ( $3200^{\circ}\text{F}$ ). This variation in melting temperature is probably due to different carbon contents in the carbide.

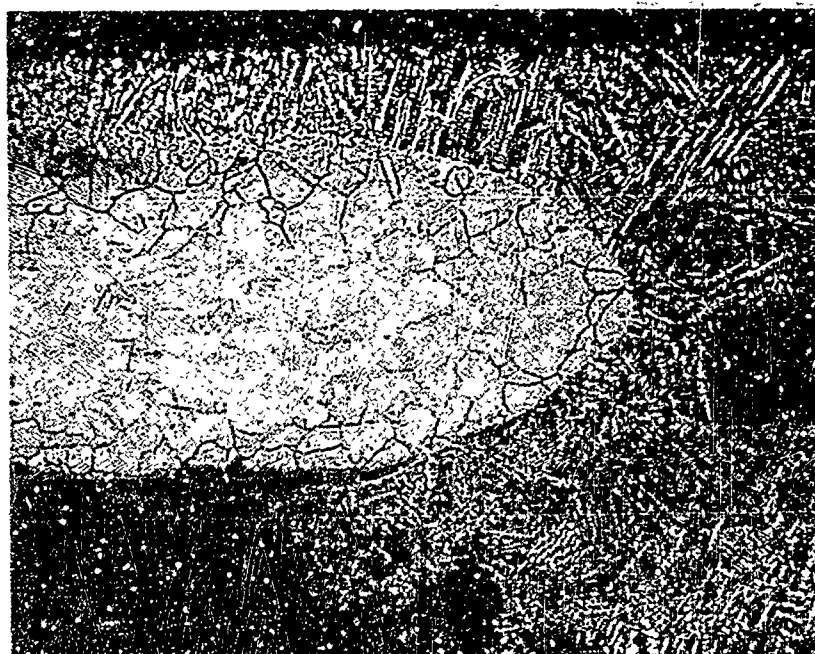
Figure 13. Microstructure of Distressed Type 347  
Stainless Steel Tubes Etched in Aqua Regia  
and Oxalic Acid

internal surface is shown in Fig. 13(a). Occasional melting can occur as shown in Fig. 13(b).

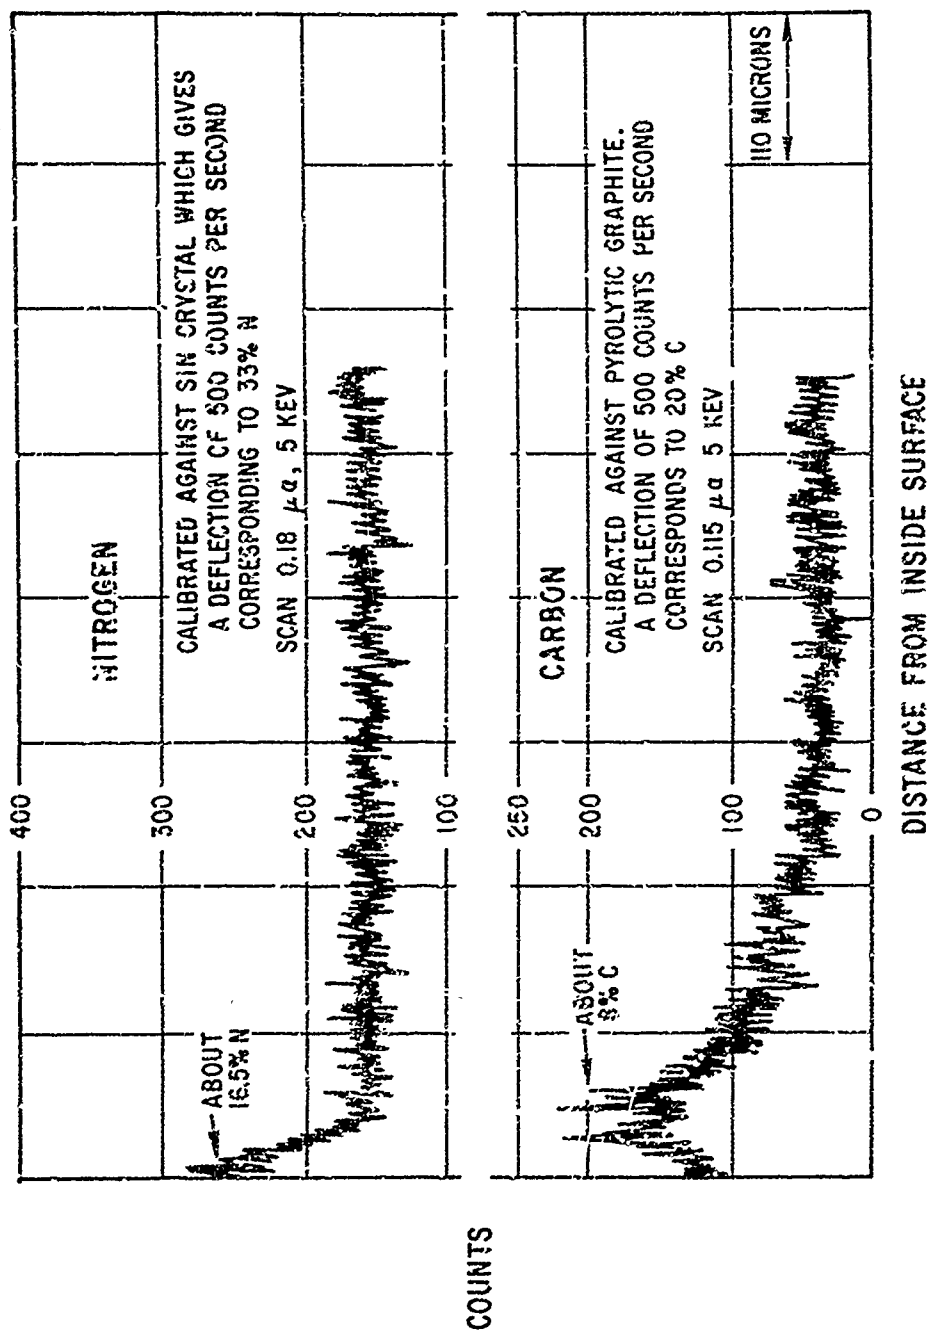
Figure 14. Microprobe Traverse on Inside of Distressed Type 347  
Stainless Steel Tube

A microprobe traverse was made on the distressed tubes to identify the carburized and nitrided zones (Fig. 14).

Microprobe and metallographic analyses indicated two zones on the inside surface of the stainless steel tubes - a dark etching carburized structure consisting of carbide ( $\text{Fe} \cdot \text{Cr}_7\text{C}_3$ ) and austenite, and a light etching constituent, superimposed on the carburized layer, consisting of nitride ( $\text{Fe} \cdot \text{Cr})\text{N}$ .

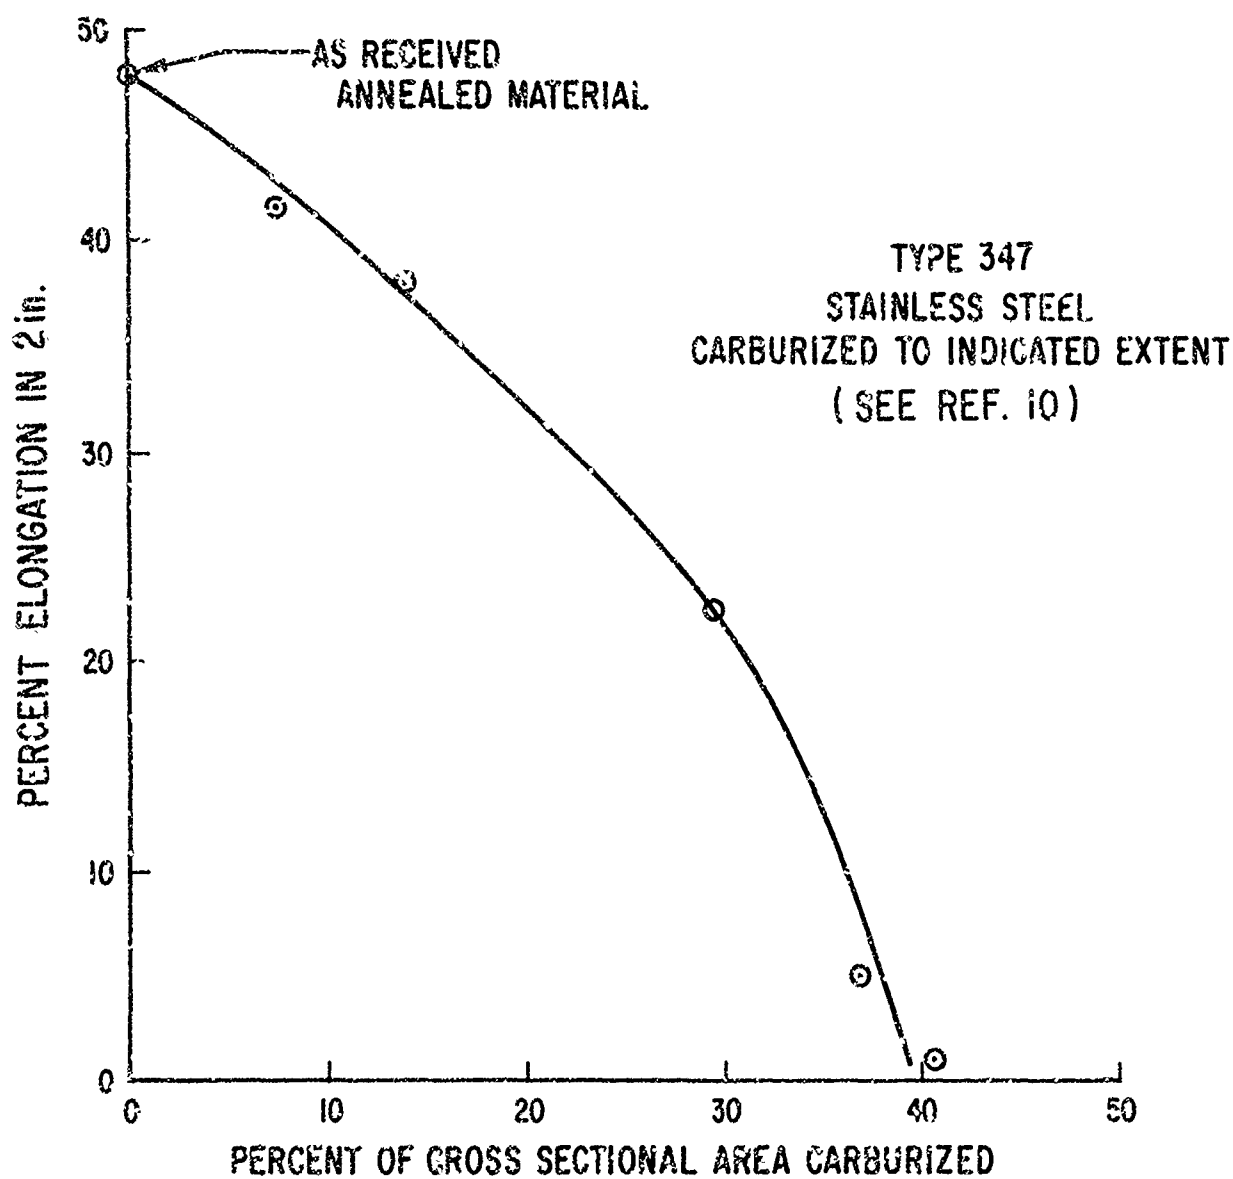
Figure 15. Decrease in Ductility in Relation to Carburization in Type 347 Stainless Steel

One unfortunate consequence of carburization in Type 347 stainless steel is the loss of ductility (Ref. 10). See Fig. 15. Figure 16 shows the cracking that develops when a carburized steel is pulled in tension. The specimen was originally carburized in 1-1/2 vol % methane in hydrogen for 1 hr at 980°C

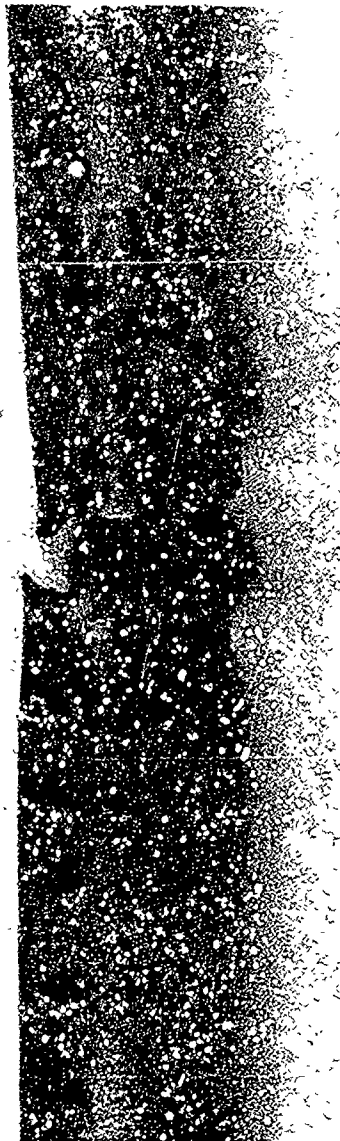
Figure 16. Cracking of Carburized Type 347 Stainless Steel  
Tubing Tested in Tension

(1800°F). The formation of a nitride case decreases the ductility of the Type 347 steel even more than does the carburization (Ref. 11). Similar cracking occurs.
